**REPORT ON THE MICHAEL FARMHOUSE
FORMERLY KNOWN AS THE JAMES ROGERS HOUSE
645 HOLDERNESS ROAD
SANDWICH, NEW HAMPSHIRE
MAY 22, 2021**

ARCHITECTURAL HISTORY HISTORIC PRESERVATION

JAMES L. GARVIN
FARRINGTON HOUSE

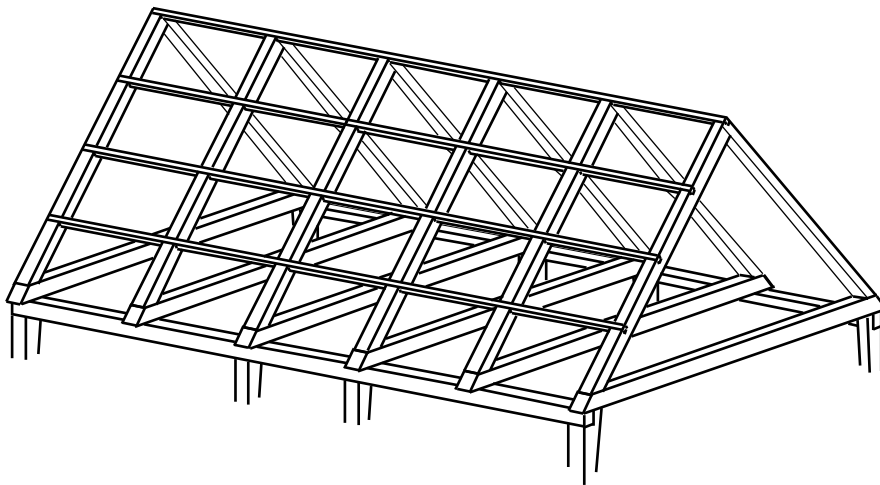
Roof Frame: Principal Rafters and Purlins (rear purlins omitted for clarity)

The roof frame of the front house, and indeed the roof frames of every structure on the property, is composed of principal rafters and longitudinal purlins, as shown above. Such a roof frame ordinarily denotes a structure that dates from the 1830s or earlier. However, the same framing principle is used on all of the Michael Farmhouse buildings, including the freestanding two-bay automobile garage, so it may be that in the Sandwich area the older roof framing type, seen here, was retained much longer than elsewhere in New Hampshire.

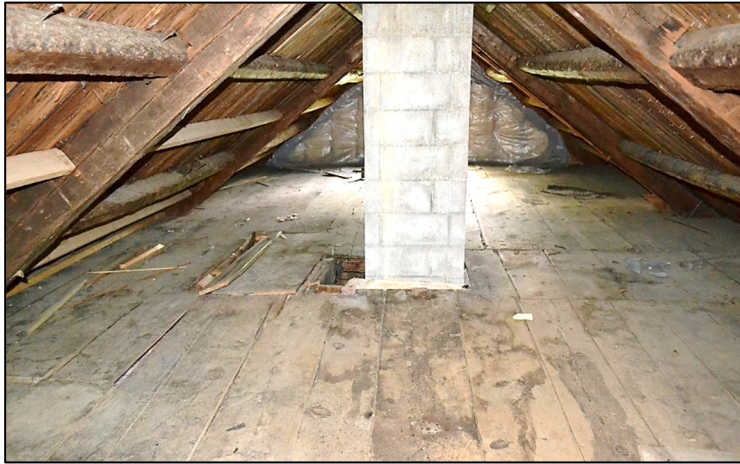
The attic of the Cape Cod house is seen at the left; the camera is facing northwest, toward Holderness Road. The hewn rafters and heavy original purlins are visible, as are some sawn auxiliary purlins that were added to support the roof sheathing boards under the weight of snow. The attic floor boards are sawn on an upright or reciprocating water-powered sawmill of the type that was common prior to the mid-1800s, and persisted after that date in small sawmills.

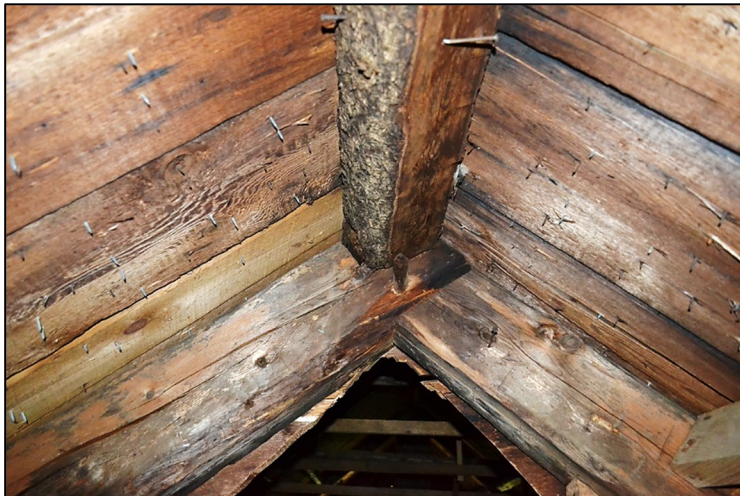
At the left is seen the intersection of a pair of rafters and the ridgepole. All roof framing members were hewn with a broadaxe and were not smoothed with an adze. Portions of both rafters and the ridgepole retain the bark of the tree in some areas. This is rough but very serviceable carpentry.

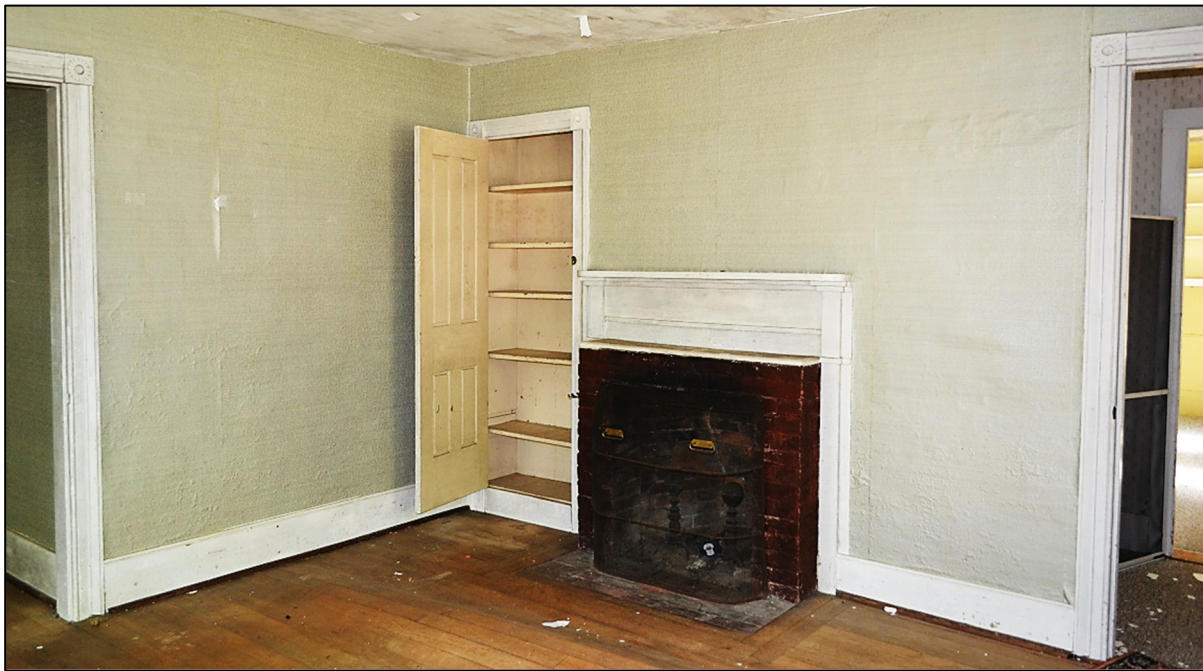
Parlor of the Cape Cod house, camera facing east

As seen in the photograph above, the joinery in the parlor is simple in detail, matching the style of the exterior woodwork. Diagnostic details of the Greek Revival style of this room are shown on the following page. This room retains a working fireplace, but the central chimney of the house has been rebuilt, and the opposite side, which normally would have had the large kitchen fireplace, now has only a brick platform for a woodburning stove. As seen in the photograph on page 5, the chimney was rebuilt with concrete blocks through the attic. It is built of brick above the roof.

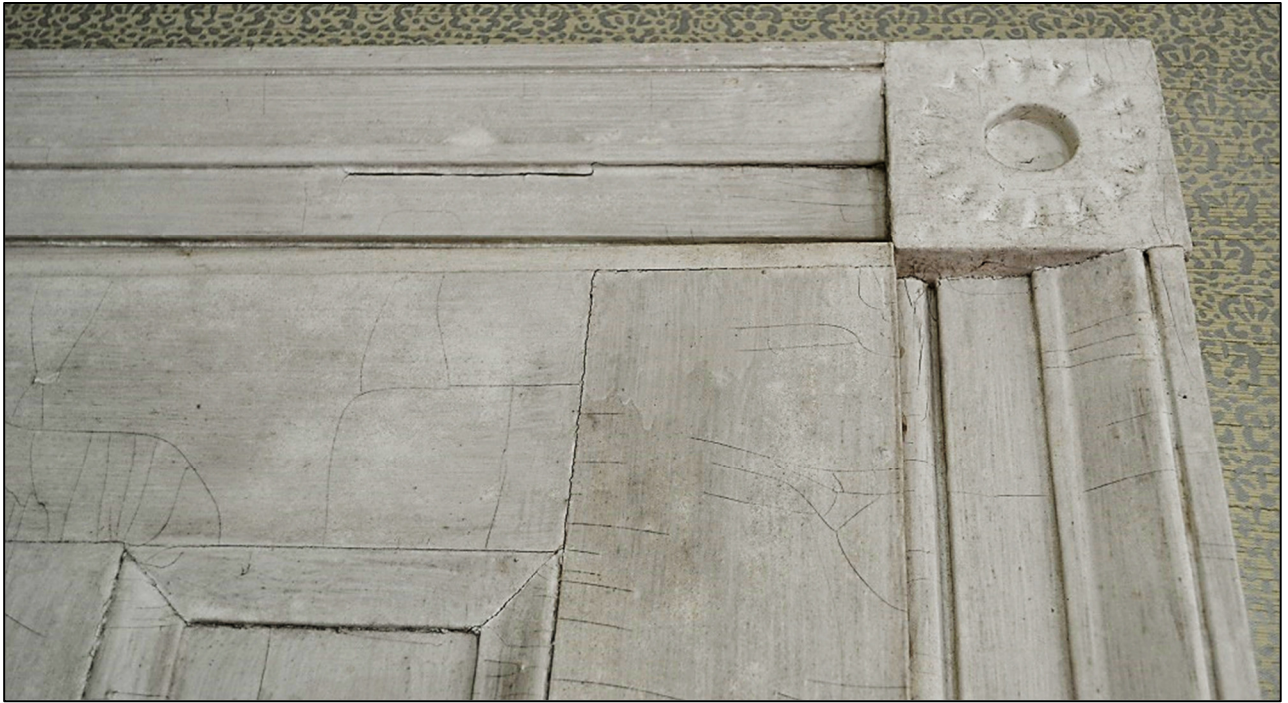
Detail of Door Casing, Corner Block, and Door Panel in Parlor. The chip carving on the corner block is highly unusual.

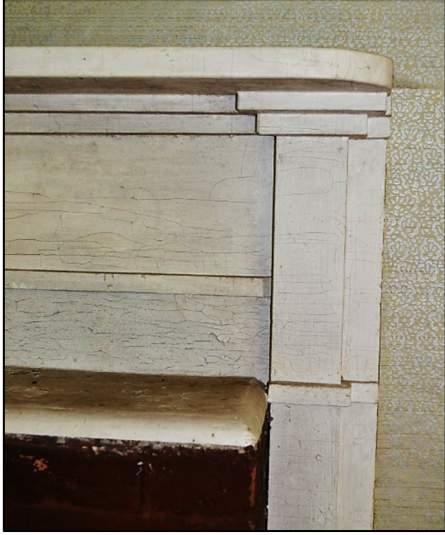
A detail of the parlor mantelpiece, shown at the left, shows that it adheres to the very plain Greek Revival style, contrasting with the rather sophisticated door casings and doors of this room.

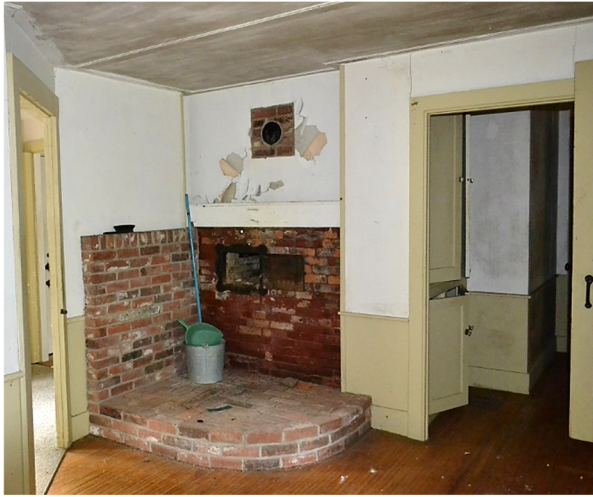
As noted above, the chimney of this house has been at least partially rebuilt in modern times, having a shaft of concrete blocks, seen on page 5 of this report, above the first story and below the roof. The western room of the house has a fireplace, but the eastern room, shown below, now has a brick platform for a woodburning stove. The face of the chimney adjacent to this platform has a cast iron door for a brick oven, undoubtedly retained from the chimney as it formerly stood.

Left: Original kitchen fireplace wall with new stove platform.

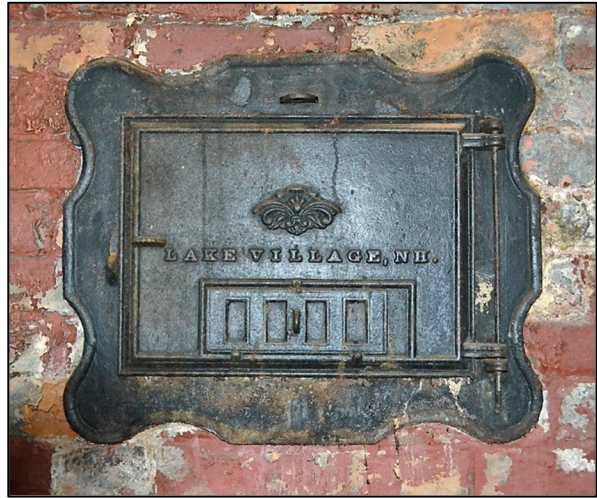
Right: Oven door cast in Lake Village (Laconia), New Hampshire.

The oven door shown above is of a well-known pattern. Doors with identical frames were cast in a number of New Hampshire foundries, including those in South Newmarket (Newfields) and Concord. The doors bear different names depending on the manufacturer. Most of those made in South Newmarket bear the date "1849." On the basis of that evidence, doors of this pattern are regarded as diagnostic of a date of circa 1850. As discussed earlier, this approximate date correlates with the appearance of the woodwork in the western room of this house. Because a chimney would normally be dismantled from a house that was to be moved, and reconstructed in the new location, the oven door of circa 1850 strengthens the likelihood that this house, and presumably its companion structures, were moved to this site and joined together around 1850.

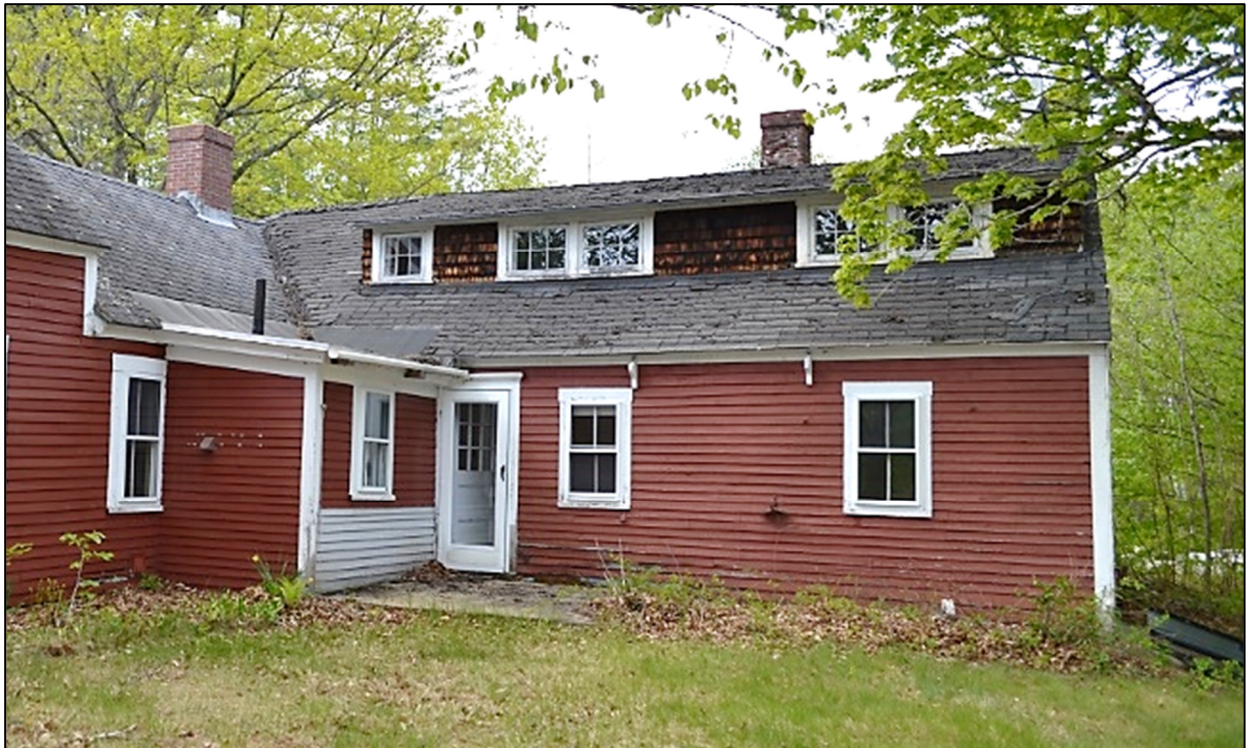
As seen in the photograph below, the eastern slope of the roof of this structure was provided with a shed dormer to light the bedrooms. As noted previously, a wintertime photograph of 1922 of James Rogers and his automobile shows that the dormer had been added to the roof by that date.

Second Building Frame, attached to the rear of the Cape Cod House. Camera facing west. The flat-roofed extension to the left with a plumbing vent is an added bathroom.

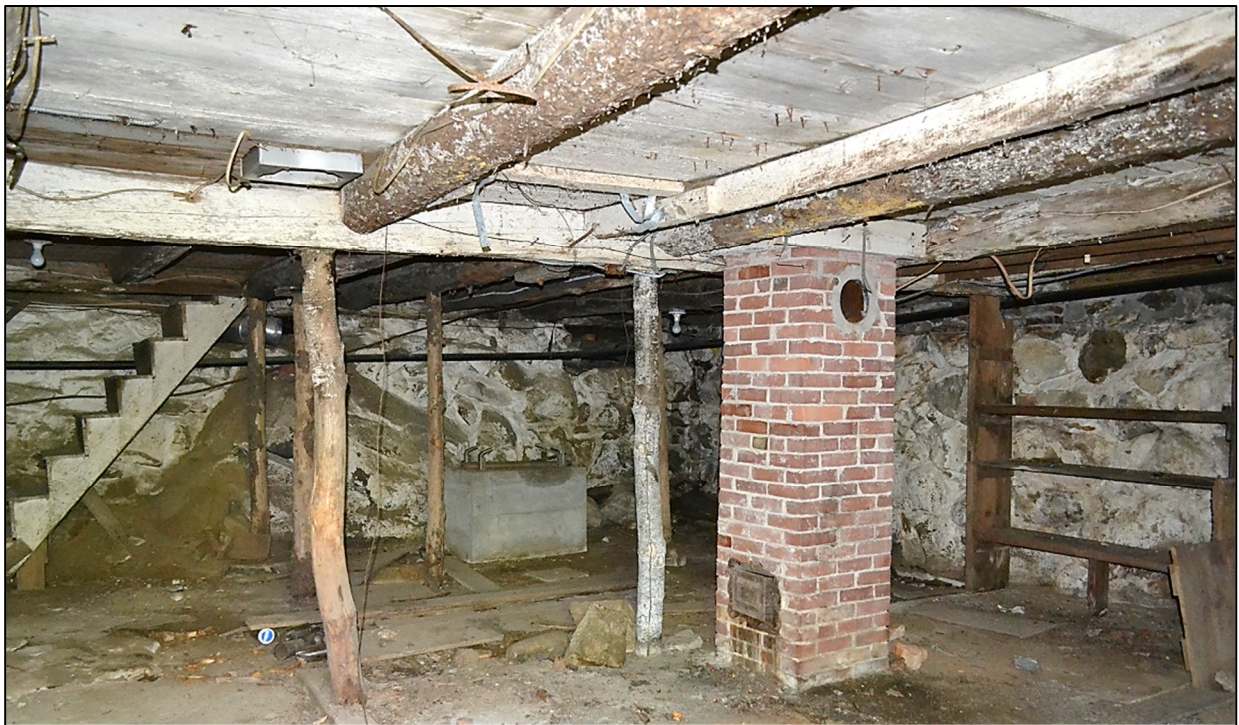
While there is no cellar under the Cape Cod house, the rear wing was provided with a deep cellar that extends under the full frame. As seen below, the stones of the cellar walls are mortared, not laid dry, and are whitewashed. They may have been bedded in mortar from the date of construction, although dry-laid foundations were not rare in the mid-1800s. The cellar wall on the east, facing the back yard of the L-shaped assemblage, has been reinforced with a concrete wall that extends about two-thirds up the height of the stone wall. The concrete wall was bolstered by two concrete buttresses, now mostly removed. This added concrete indicates that the eastern cellar wall was failing, probably from the pressure of earth made more plastic by water falling from the roofs of both gable-roofed units, which meet in a valley as seen on the previous page.

Cellar of the rear house, camera facing southwest. The cleanout door at the base of the chimney matches the oven door shown on page 8 and was probably the door of the ash pit that would have been placed under the oven. The protrusion under the cellar stairs is a large boulder or ledge that was too massive to split and remove when the cellar was excavated.

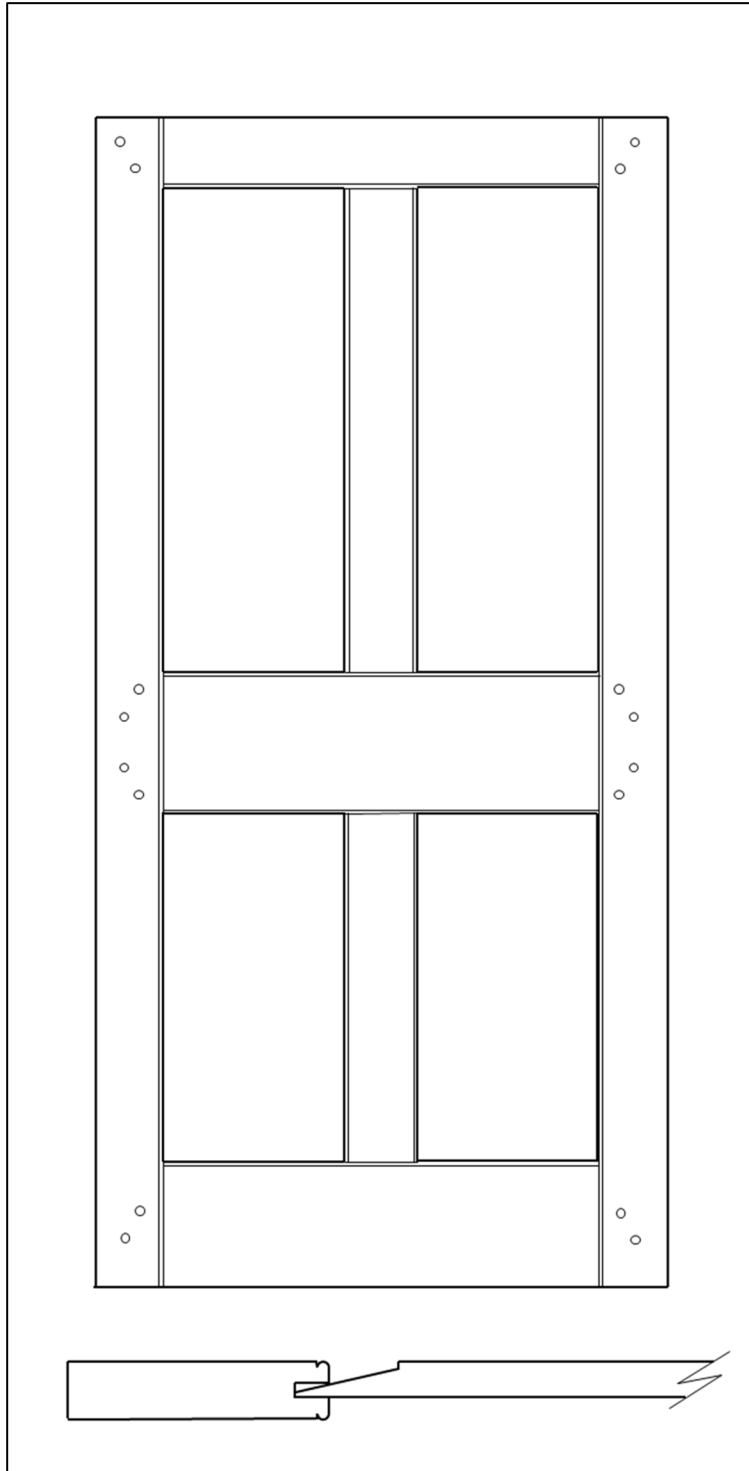
The type of door seen in the rear house is shown at the left. It is a four-panel door with flat panels on one side, which is usually treated as the face or best side of the door. The flat side is shown in the drawing. The sectional view at the bottom shows the raised field of the panel on the opposite side of the door.

This type of door dates from the end of the Federal period of joinery and carries into the early Greek Revival period, which began around 1830. It is simple in its detailing and was probably most commonly fashioned for less expensive or less elaborate houses.

Where such doors have been found in datable houses in New Hampshire, they generally date from about 1835. This may be the period of the surviving early joinery in the rear house. We may theorize that this rear unit was constructed elsewhere around 1835 and moved to the present site around 1850. While the front house was given fashionable woodwork of the 1850 period at the time of the move, the rear house was apparently left with much of the interior finish that it had at the time of the move.

Left: Drawing of one of two identical doors found at the northernmost end of the first story of the rear house.

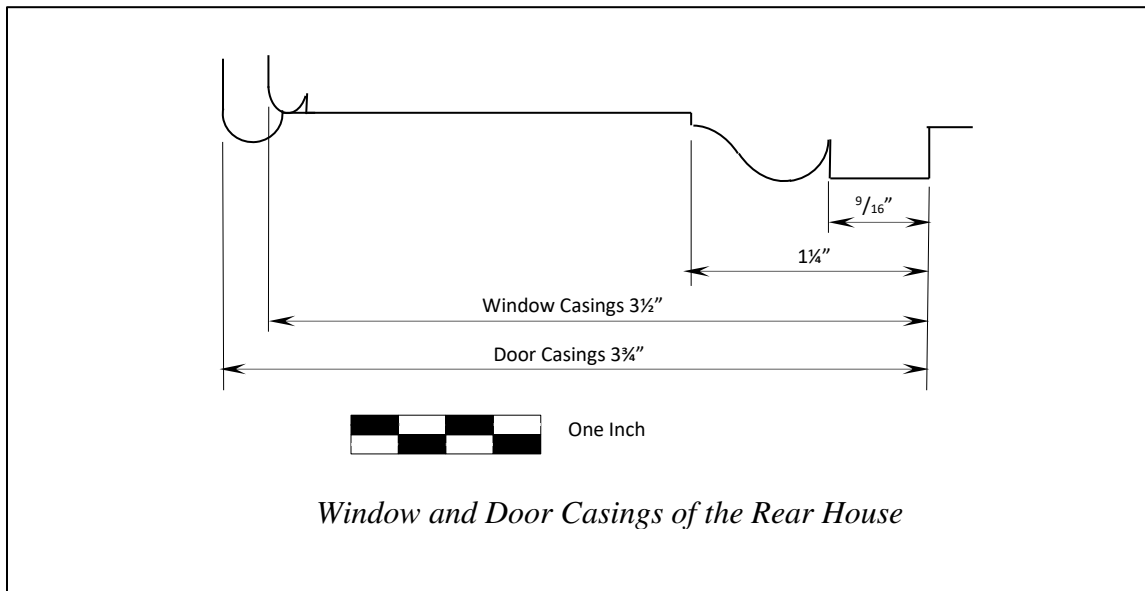
Where undisturbed by remodeling, the window and door casings on the first story of the rear house also display profiles that reflect simple joinery of the late Federal or early Greek Revival period, as shown below, correlating with the style of the four-panel doors.

From these features of the joinery, it appears that the interior of the rear house was finished about 1835.

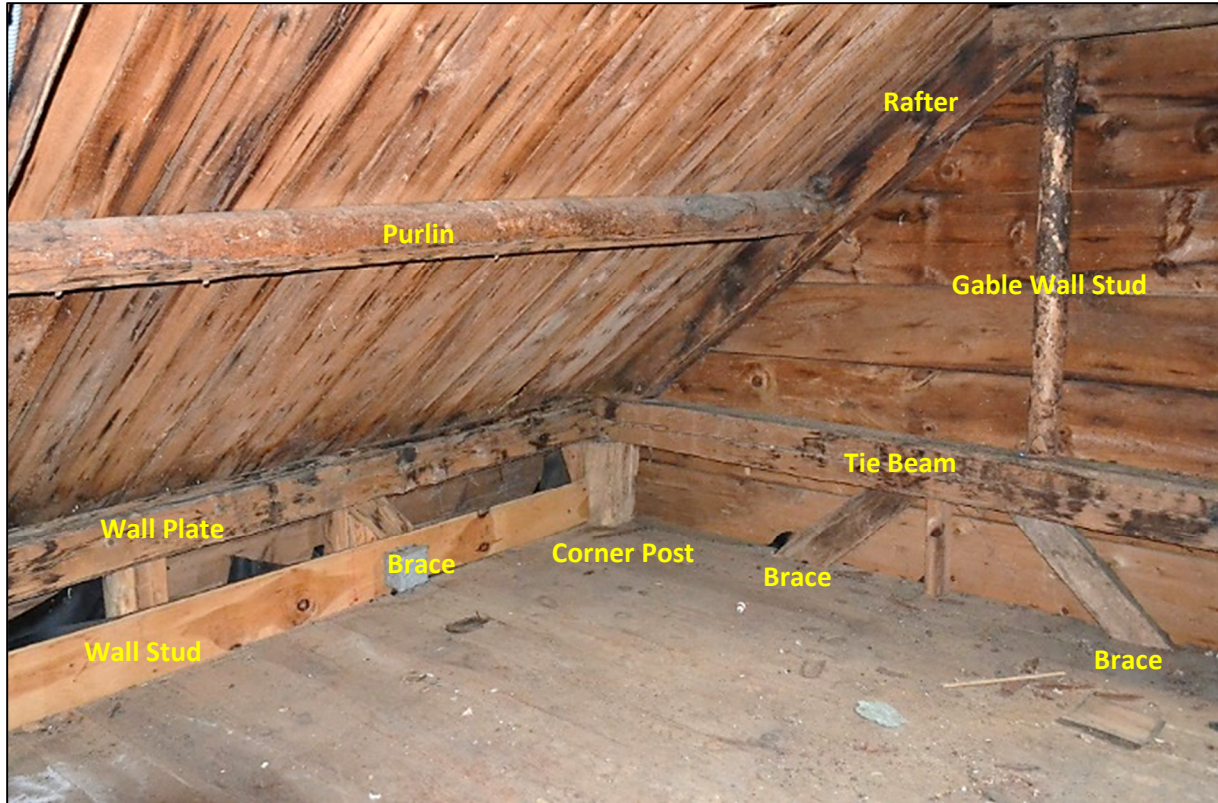
Northeast corner of shop attic, camera facing east. The framing of the kneewall is exposed.

The photograph above shows the corner framing of the building. It can be seen that the tie beam, which supports the end rafter, laps over the wall plate. The tie beam and the plate are flush at their bottoms and seem to rest directly on the top of the corner post without a complex framing joint. This type of simplified framing is characteristic of the 1840s or 1850s, although it can occur earlier.

Tie beams act in tension to resist the outward thrust of the rafter feet, which naturally tend to spread under the weight of the roof materials and especially under the weight of snow. At the opposite end of the shop, where the building abuts the gable end of the Cape Cod house, the tie beam was cut long ago to permit passage between the attics of the two buildings without obstruction. Severing the tie beam at that end weakened the frame, but there is no obvious sign of structural movement. This is probably because the gable of the shop, being attached to the gable of the house, receives some support from the latter. The spreading tendency of rafters is diminished by the presence of gable wall studs like the one seen in the photograph above.

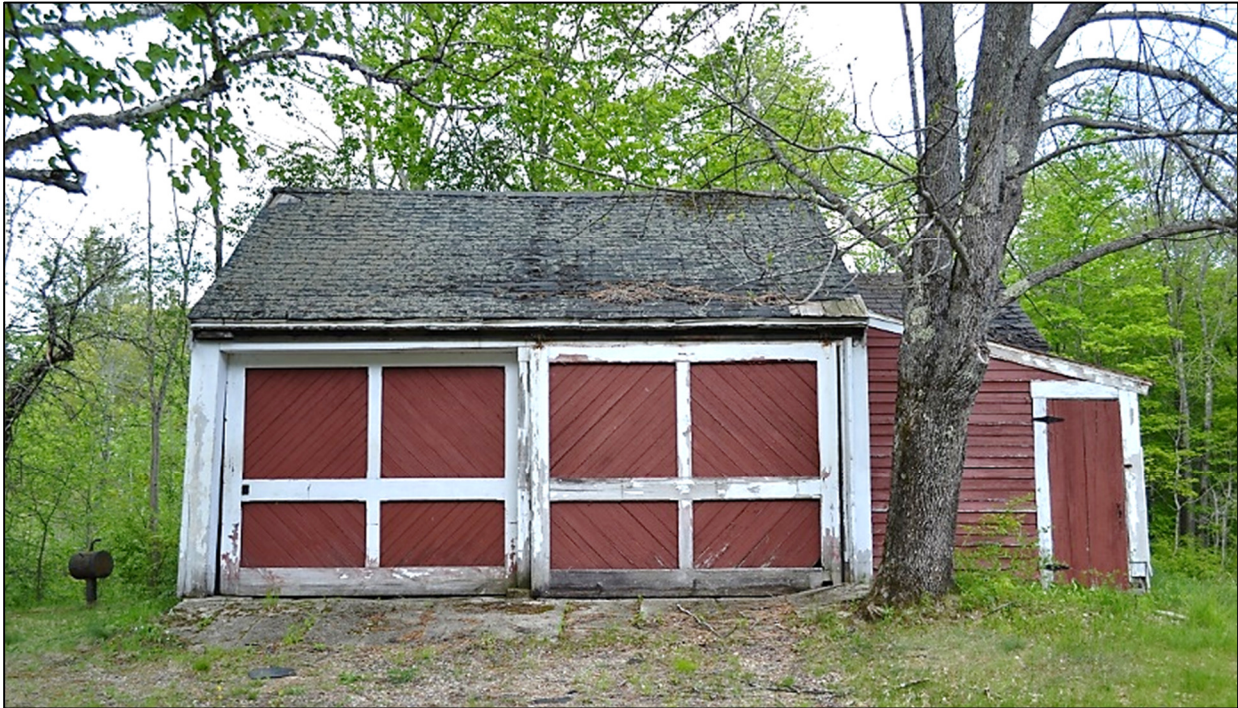
Standing alone to the east of the connected buildings is a two-bay garage for motor vehicles. The garage has a two-part shed connected to its southeastern end, one portion of which could formerly have been a privy.

The detailing of the garage, with its heavily framed sliding doors and diagonal sheathing, suggests a date of the 1910s or 1920s. Inside, the garage has wood-sheathed side walls and a concrete floor, adding to the substantial, early-twentieth-century appearance of the building. The rear (northeastern) wall of the garage was extended by a shed-roofed addition to accommodate longer vehicles, a common alteration of garages that were originally proportioned for Ford automobiles or trucks.

This garage displays one anomaly: it is framed with a rafter-and-purlin roof like those of the connected buildings, although more crudely hewn and more lightly framed. As noted previously, such roof frames generally gave way to roofs of closely-spaced common rafters during the 1830s. It is hard to believe that any carpenter would frame a building with such a roof in the age of the automobile. This suggests the possibility that the garage, like the shop, may be a remodeled agricultural outbuilding of a relatively early period, thoroughly disguised with well-fashioned doors and trim in the early twentieth century.
