**REPORT ON THE MICHAEL FARMHOUSE
FORMERLY KNOWN AS THE JAMES ROGERS HOUSE
645 HOLDERNESS ROAD
SANDWICH, NEW HAMPSHIRE
MAY 22, 2021**

ARCHITECTURAL HISTORY HISTORIC PRESERVATION

JAMES L. GARVIN
FARRINGTON HOUSE

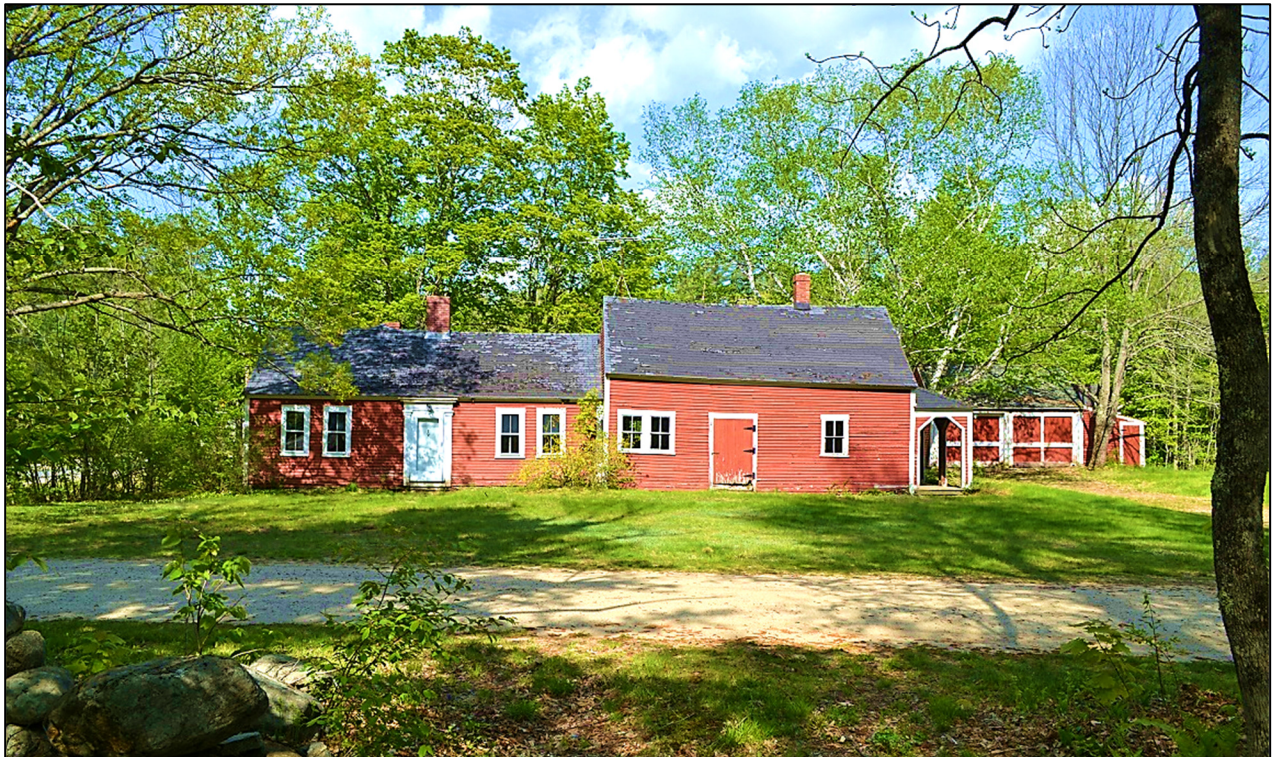
Michael Farmhouse Complex, Sandwich, New Hampshire. Camera facing Northeast

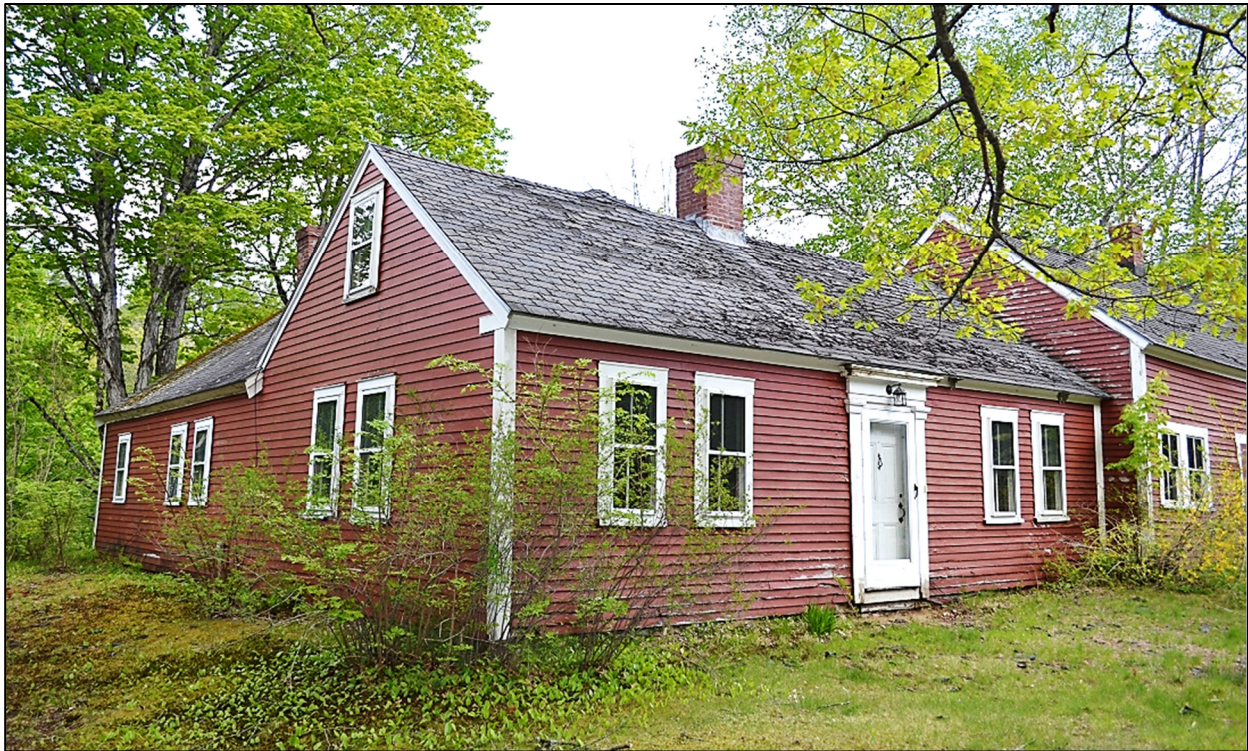
Cape Cod structure, Michael Farmhouse. Camera facing East.

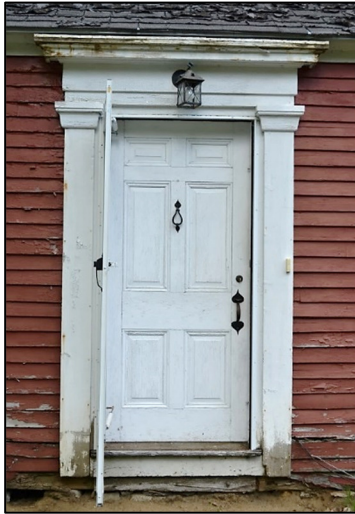
The same simplicity is seen in the front doorway of the house. Although the doorway has some molded features, its general expression is one of deliberate simplicity and plainness. This would have been recognized as stylistically modern in the mid-1800s.

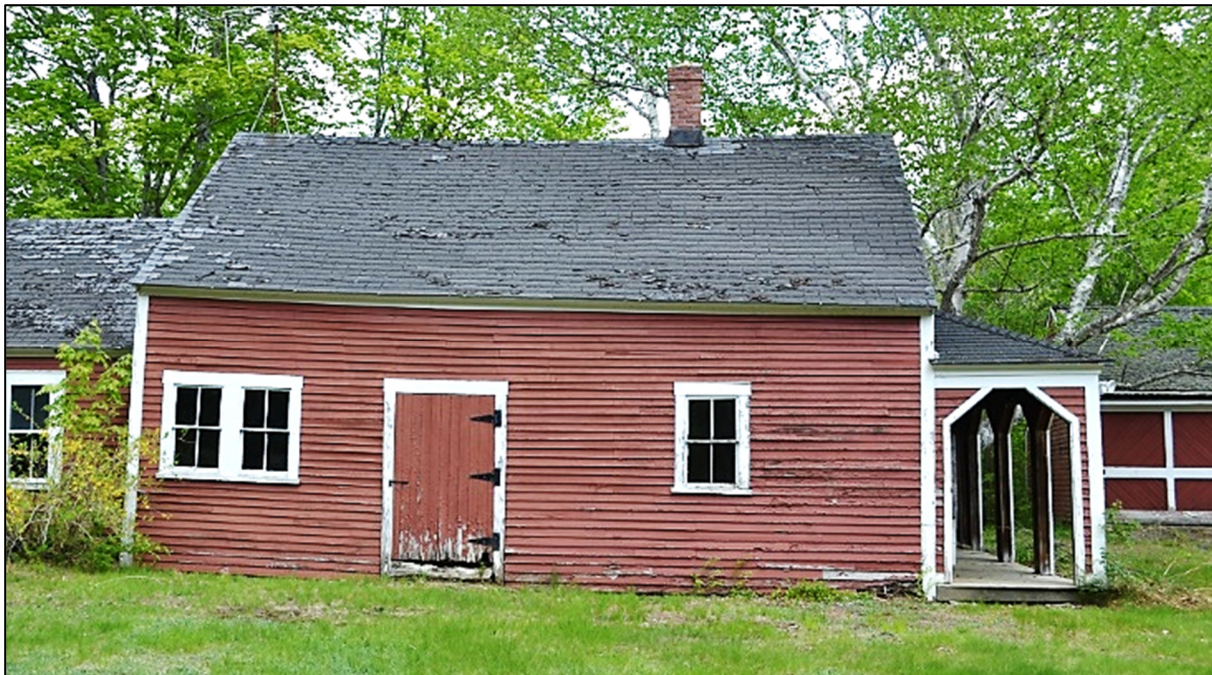
Shop Building. Camera facing Northeast.

The shop building was an important place of work for James Rogers, who was a skilled woodworker as well as a trained forester. The building is attached directly to the eastern gable end of the Cape Cod house. The clapboards of the house, retaining an early dark paint and showing few signs of weathering, remain on the house and are visible from the shop at a door that connects the attics of the two buildings.

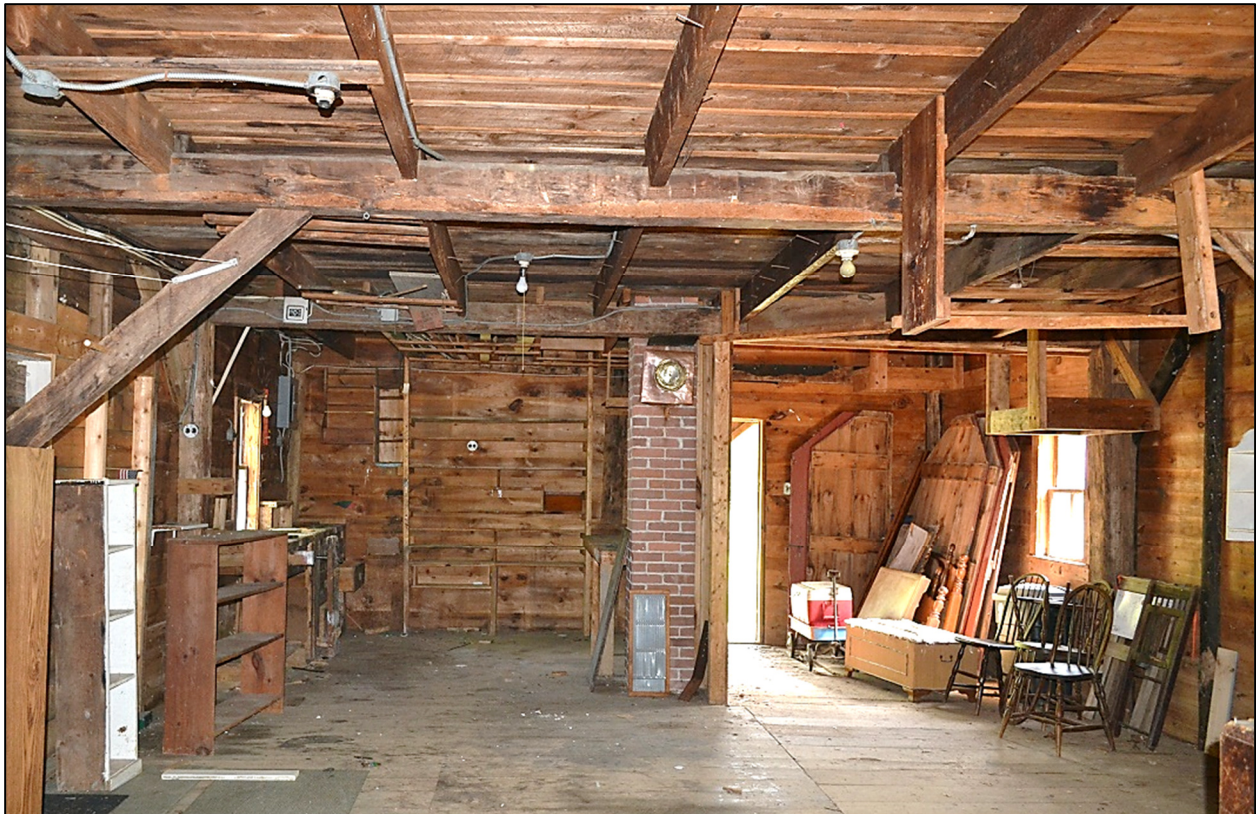
Shop building. first story, camera facing southeast.

The building is framed with hewn timbers. As in the roof system of the Cape Cod house, the timbers were hewn with a broadaxe and not further smoothed. The roof of the shop, like that of the Cape and presumably of the rear house, is a rafter-and-purlin frame of the type shown on page 4 of this report. The principal difference between the shop's roof frame and those of the two houses is the fact that the shop has a kneewall frame. In such a frame, the second story is supported by posts (and sometimes girts) that lie well below the wall plates that receive the feet of the rafters. The wall posts of the frame extend without break to the bottoms of the wall plates. Sawn diagonal braces connect posts and wall plates (and the gable-end end tie beams of the structure), stiffening the frame against racking from wind pressure or eccentric snow loading.
